TOPSOIL MOVEMENT & CONSTRUCTION RECORD

PHASE I

LILA CANYON MINE

December 2008-February 2009

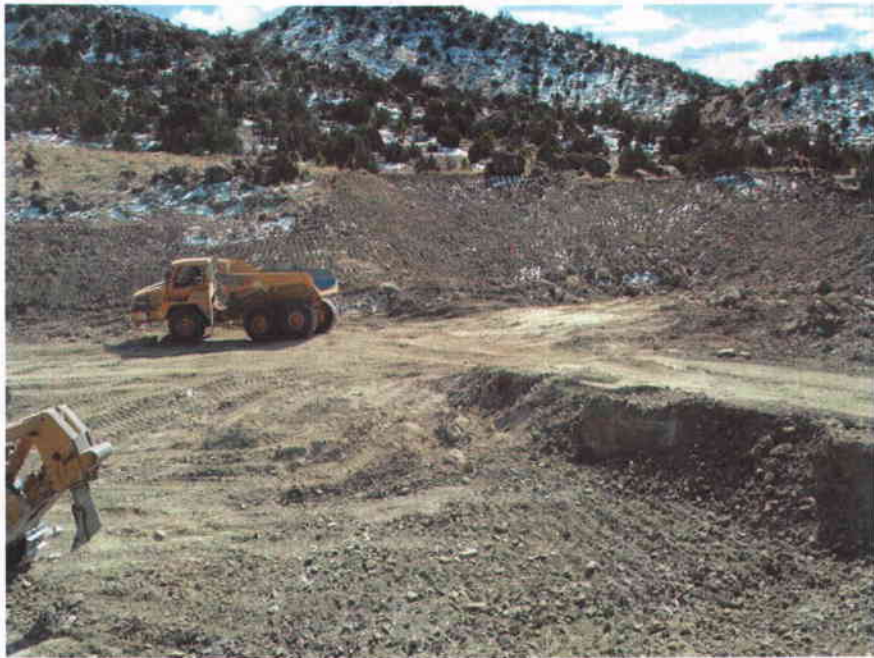
WEST END LARGE SRP

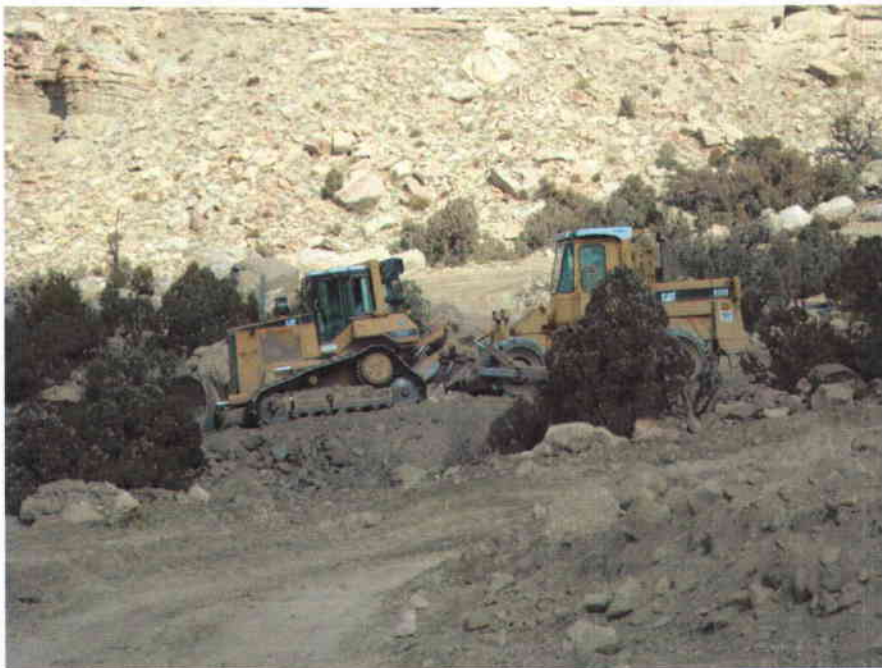
FINAL WORK ON PORTAL ROAD

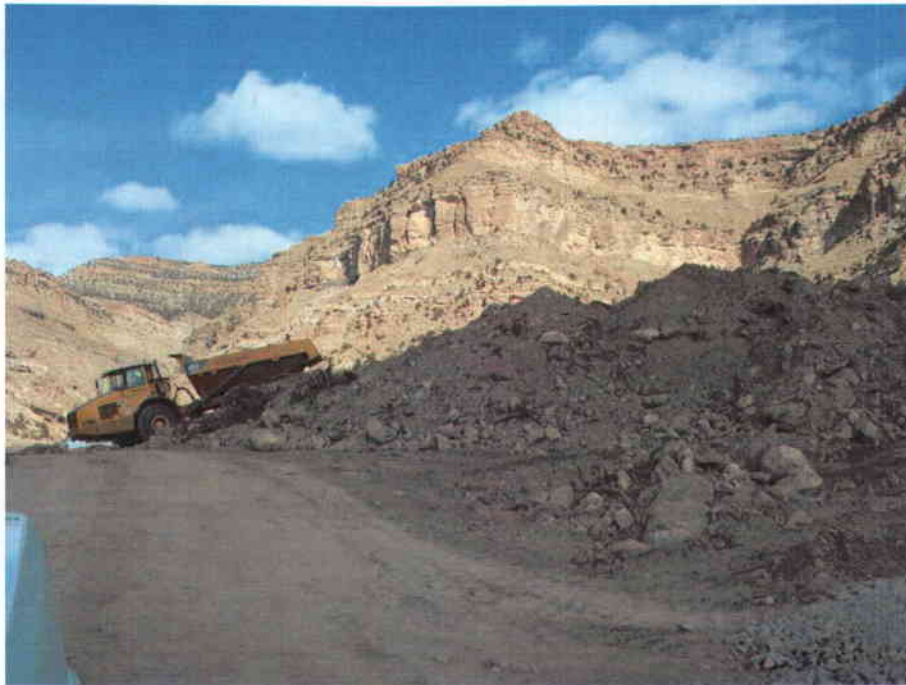
TOPSOIL PILE LOOKING NORTHEAST

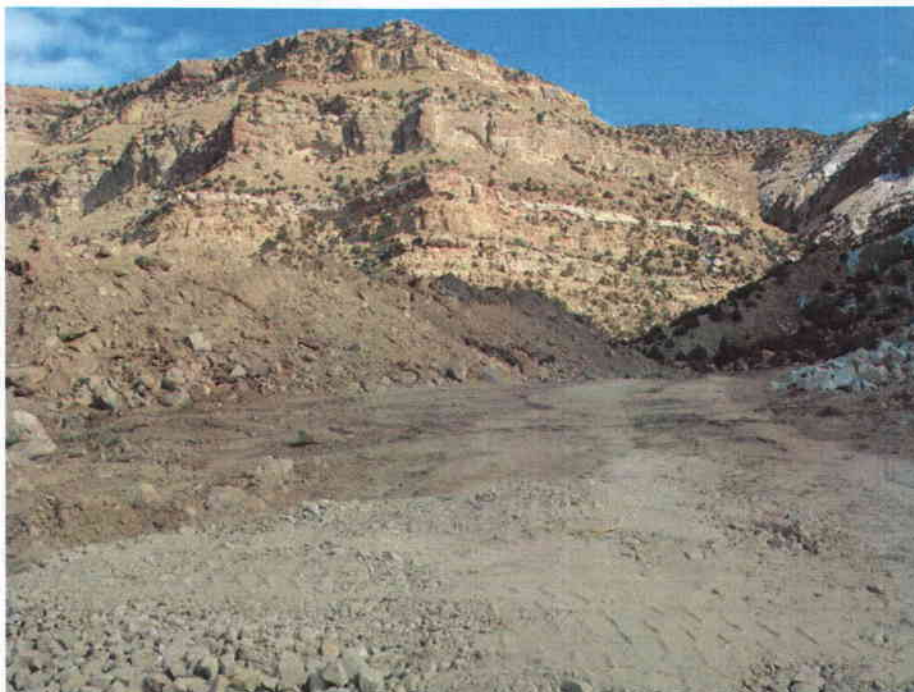
TOPSOIL PILE LOOKING SOUTH EAST
